DEPARTMENT OF TRANSPORTATION

Contract #: 04-0120F4Cty: SF/ALA Rte: 80 PM: 13.2/13.9File #: 69.28**WELDING INSPECTION REPORT****Resident Engineer:**Siegenthaler, Peter**Address:** 333 Burma Road**City:** Oakland, CA 94607**Report No:** WIR-017840**Date Inspected:** 07-Nov-2010**Project Name:** SAS Superstructure**OSM Arrival Time:** 645**Prime Contractor:** American Bridge/Fluor Enterprises, a JV**OSM Departure Time:** 1845**Contractor:** Zhenhua Port Machinery Company, Ltd (ZPMC), Changxing Island **Location:** Shanghai, China**CWI Name:** An Qing Xiang.**CWI Present:** Yes No**Inspected CWI report:** Yes No N/A**Rod Oven in Use:** Yes No N/A**Electrode to specification:** Yes No N/A**Weld Procedures Followed:** Yes No N/A**Qualified Welders:** Yes No N/A**Verified Joint Fit-up:** Yes No N/A**Approved Drawings:** Yes No N/A**Approved WPS:** Yes No N/A**Delayed / Cancelled:** Yes No N/A**Bridge No:** 34-0006**Component:** Orthotropic Box Girder(OBG)**Summary of Items Observed:**

Trial assembly yard, 11CE-11DE, SP-EP-B3.

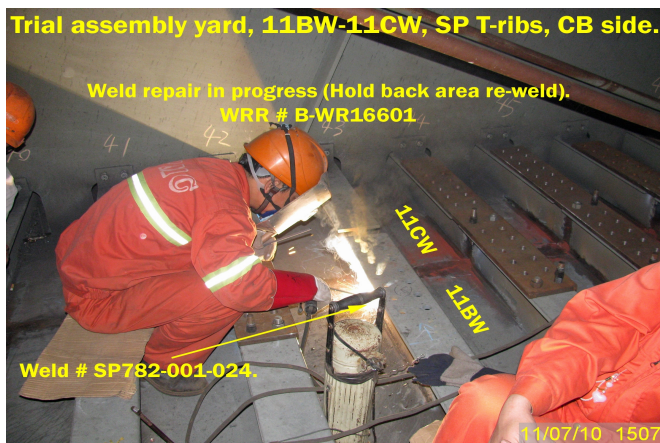
SMAW Re-welding of T-ribs SP782-001-017, 018, 023, 024 (WRR # B-WR16601); located at Trial assembly yard. Welders are identified as 202316, 251194; ZPMC Quality Control Inspector (QC) is identified as Zhu Zhong Hai. The welding variables recorded by Quality Control Inspector (QC) appeared to comply with the Applicable WPS: WPS-B-P-2212-FCM-1. The attached photographs provide additional detail.
